# **OPERATING EXPERIENCE WEEKLY SUMMARY**

**Office of Nuclear and Facility Safety**

**September 10 - September 16, 1999**

**Summary 99-37**

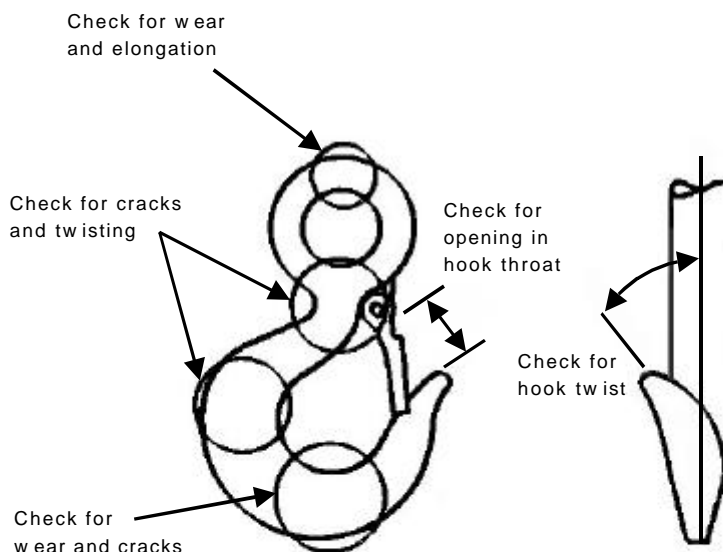
**Figure 2-1. Rigging Hook Inspection Points**

This event underscores the value of conducting a pre-use inspection of the rigging hook as performed by the operators who identified the deformed accessory hook. The inspection should include: (1) checking for distortions such as bending and twisting that exceeds 10 degrees from the plane of the hook and 10 degrees from the point of the hook to the plane of the center axis of the hook, (2) checking for an increase in hook throat opening that exceeds 15 percent of the original opening (most hooks have punch marks as reference points), (3) checking for wear in

the saddle and eyelet area that exceeds 10 percent of the original dimension, (4) checking for cracks, severe nicks, and gouges, and (5) checking the hook attachment for defects. Figure 2-1 shows inspection points for a rigging hook.

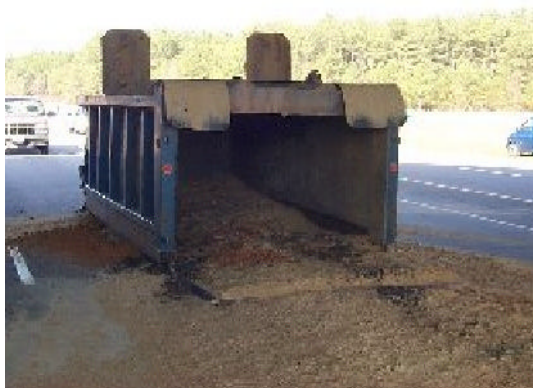
**Figure 1-1. Detached Dump Bed**

Upon impact, the dump bed sheared two hinge pins on the rear of the truck chassis and the connecting pin for the lift cylinder and came to rest inverted beneath the overpass (Figure 1-1). The front of the truck chassis raised into the air, slammed back down onto the pavement, and stopped approximately 200 feet further down the road. The impact with the pavement broke the shock mounts from the front axle, drove the engine and transmission through their mounts and into the pavement, bent the truck's frame, bent the rear tandem axle, and separated the two interior tires from their wheels on the rear axle (Figure 1-2).

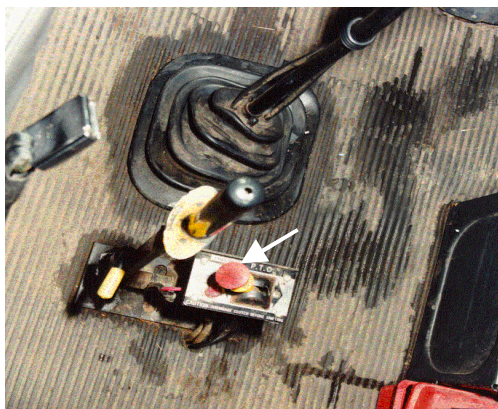
**Figure 1-3. Power Take-Off Control and Dump-Bed Lever**

Investigators determined that in order for the dump bed to raise, a power take-off control must be engaged to supply hydraulic oil and a dump-bed lever must be positioned to route the oil to the actuating cylinder. There are no engineered safety features to prevent operating the dump truck at highway speeds with the dump bed not fully seated. Manufacturers' labels warning of this condition are visibly posted in the cab. A power take-off engaged ("PTO IN") indicating light, located under the selector knob on the floor between the seats, is not visible to the driver when operating the vehicle (Figure 1-3). A "DUMP BED RAISED" indicating light on the dashboard is below the driver's field of vision during highway operation and is further obscured by a radio microphone cord (Figure 1-4). On this model of dump truck, the dump-bed lever is equipped with a spring-loaded safety pin to keep it locked in the center (neutral) position. Following the accident, investigators found the safety pin for this truck in the driver's door pocket of the cab. No driver remembers the safety pin having been in place, and no safety inspection report for this vehicle had ever noted its absence. However, inspectors determined that two dump trucks in the Savannah River Site fleet were not equipped with dump-bed lever safety pins and that the levers in two other trucks were so worn that the beds could be raised even with the pins in place.

With respect to the power take-off control, dump truck operators are instructed to always disengage the control before driving a truck onto the highway. During informal interviews with several drivers, none could claim never to have forgotten this critical step. The driver in this accident states that the power take-off control was disengaged or in the "OUT" position before the truck went on the road, and investigators found the control in that position following the accident.

With respect to the dump-bed lever, there were items of personal and government property present in the truck cab that may have made contact with the lever while the truck was on the highway. Because nothing was securing the position of the lever, it could have been moved inadvertently from the neutral position. This would have allowed the dump bed to raise if the power take-off was engaged. The dump-bed lever automatically returns to the neutral position to hold the bed up after it reaches the fully raised position. Investigators found the lever in the neutral position following the accident.

Investigators attributed the direct cause of the accident to equipment problems. Engineered safety features were inadequate to prevent the dump bed from raising while the truck was operating at highway speed, and indicating lights were poorly located or obscured. Investigators defined the root and contributing causes as management problems. Managers compromised the safety of their employees by allowing complacent safety and hazard identification attitudes to develop for routine tasks. Operators filed incomplete post-trip inspection reports, and supervisors did not routinely review them to identify problems. Managers could not substantiate adequate operator knowledge of, or training in, the safety devices for this equipment. On-the-job training for operators did not include formal instruction in the purpose or use of safety locking pins, the intent of manufacturer's warning labels, the hazards associated with raising a dump bed in transit, or the actions to be taken if the situation occurs.
